*Paper prepared for Safetynet Internet Seminar  
"Electrostatic Hazards"  
18 September 2001*

## EXPLOSION IN A FILTER

*By  
Eur. Ing. Barry Cunliffe  
Principal Process Safety Specialist  
Chilworth Technology Ltd, Beta House, Chilworth Science Park, Southampton, SO16 7NS, UK*

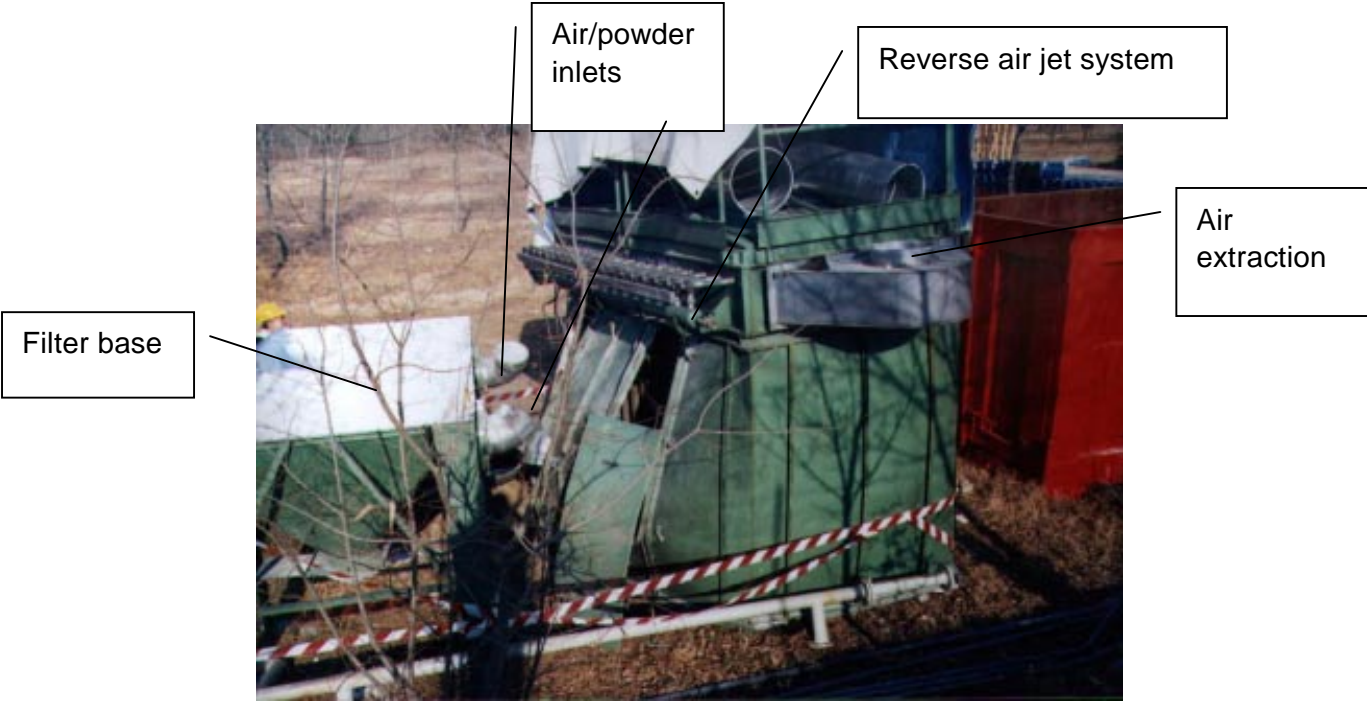
The filter was set up with a double-cone hopper under the bags so that the powder could collect in the cones, and be easily removed from the body [see photograph 1, taken after the filter body had been removed from the hopper section after the explosion]. The powder entered into each of the two cones through ductwork. The powder-laden air was drawn to the filters by extraction of air at high level above the socks. The extracted air was sent to atmosphere and the accumulated powder could be collected from the bottom of the two cones for disposal or re-use as appropriate.

1. There was structural damage to the body of the filter, and the sides were pushed outwards by an internal force. [See photograph 1.]
2. There was evidence of an explosion, and one of the filter socks had been blown into the explosion vent (albeit a very small vent) and was partially protruding through it. [See photograph 2.]

**Photograph 1:** Top of filter showing socks inside and damage to body and filter base (to left)

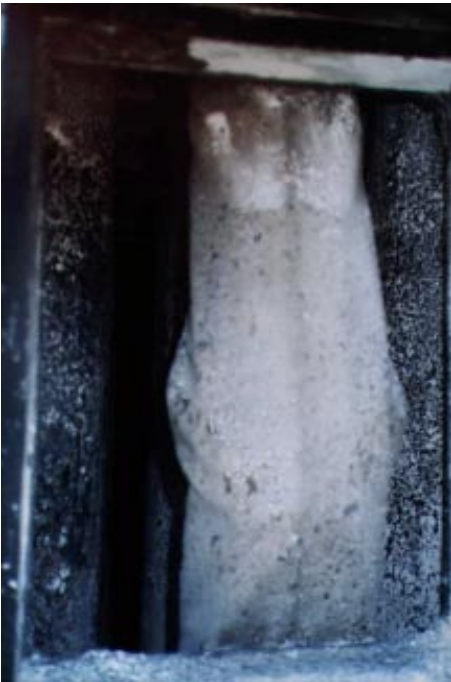
The explosion relief panel was too small and was blocked by the presence of the filter socks. Hence they were ineffective in protecting the structure of the filter body.

**Photograph 2:** Filter sock pushed through small explosion relief panel

- R1. Places where powders (that are likely to vitrify) can accumulate in process plant over periods of time should be regularly cleaned. This is especially true of locations where high charging processes are, or may be, occurring.
- R2. The vent panel should be sized correctly and should be situated below the socks. Alternatively, it should be at a level at the bottom of the socks, and with any socks that might block the vent removed, and the remainder restrained from moving into the path of the venting.
- R3. The explosion relief panel should vent to a safe location.
- R4. Explosion suppression could be considered as an option.

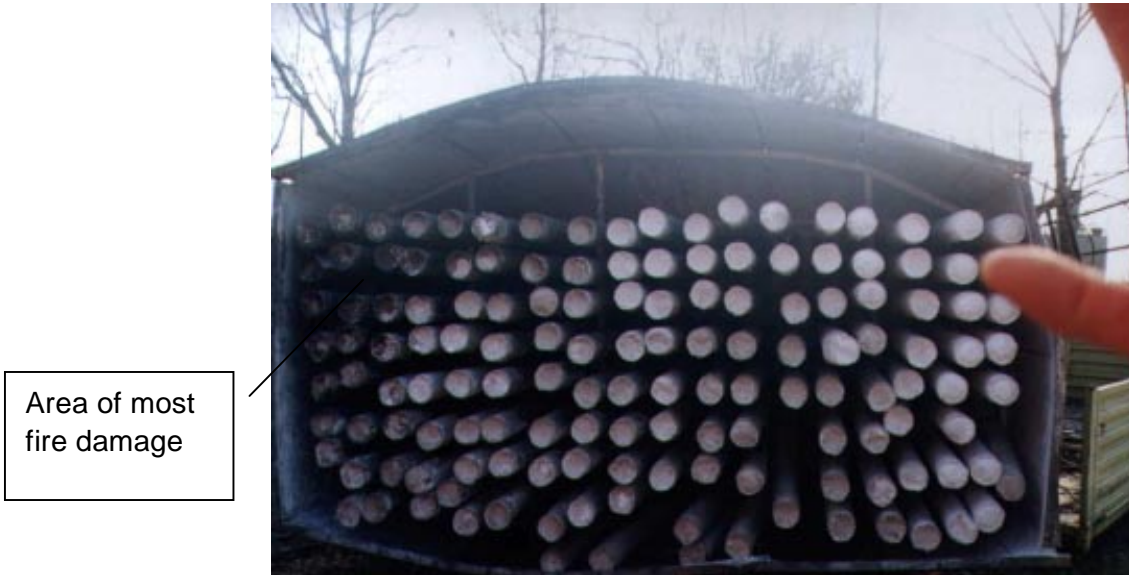
3. The bottoms of the filter socks were burnt to one side. This one side relates to where the powder had accumulated in the bottom cone and partially blocked the powder/air inlet. [See photographs 3 and 4.]

**Photograph 3:** Looking into underside of filter housing

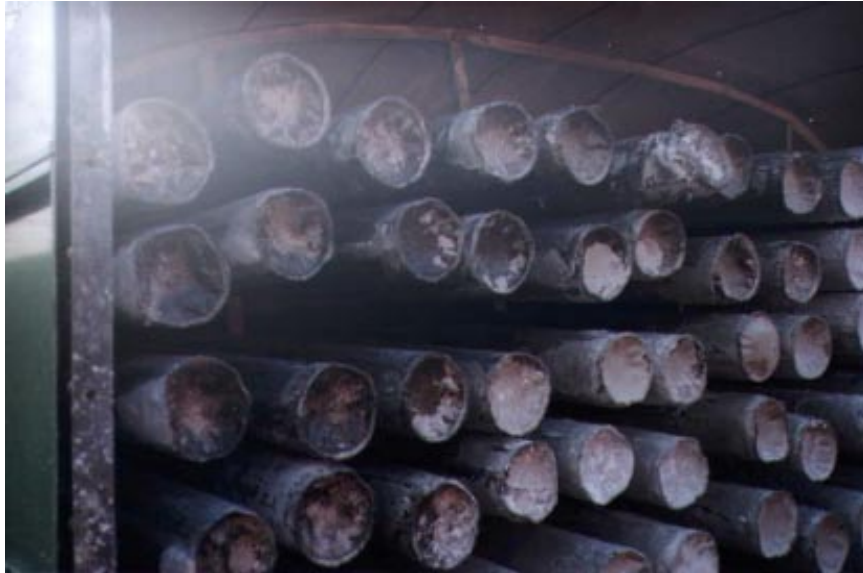
8. There was evidence of the powder vitrifying, in that over time, in the elbow of just one of the air/powder inlet lines, the powder had turned to a glassy material.

**Photograph 4:** Showing burning to one side of filter sock bottoms

Glassified material found around metalwork

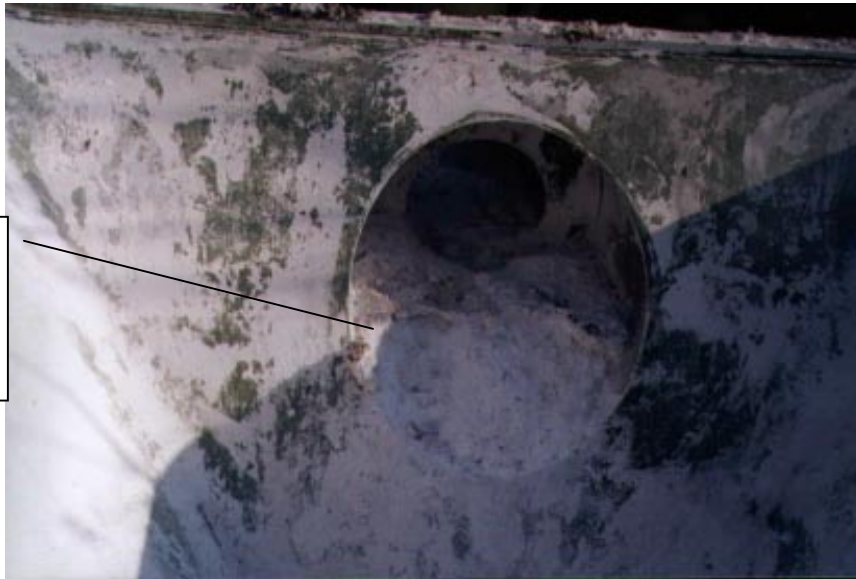
4. The bottom cones of the filter were filled with powder, such that the inlet to the filter on one side was partially blocked. [See photograph 5, which was taken after the interior had been emptied out.]

In addition, the two cones at the bottom of the filter hopper should have been cleaned out regularly. Instead, the powder had been allowed to accumulate over time. This meant that the level in the cone rose until it started blocking the inlet most in use. This caused a restriction on the diameter of the inlet, and caused speeding up of the powder/air flow.

**Photograph 5:** Inlet to filter (from inside) showing powder accumulation

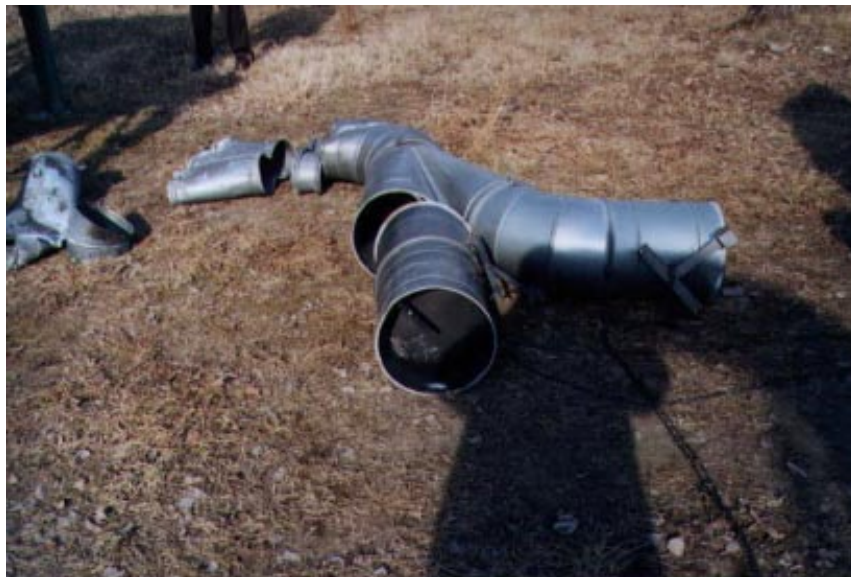
The inlet to the hopper was split into two. Due to the design of the duct, the material was more likely to favour one side of the filter. [See photograph 6.] This is because the powder/air flow would tend to travel straight on to one inlet, rather than bending to the other.

**Photograph 6:** Duct detail. The nearest two outlets fed the filter's two inlet ports
